Manhole Inspection Summary

Manhole # S2500_016MH

Insp Date: **7/26/07 9:06 AM**

Location Address: **927 BROOKS LN**

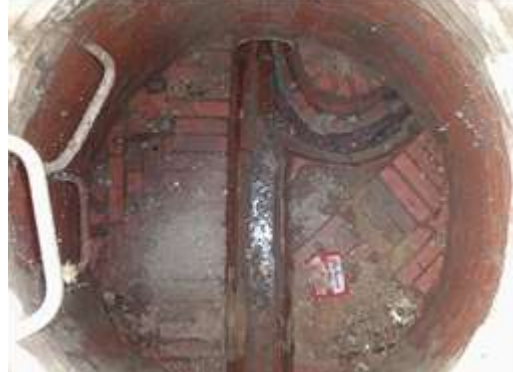
Top View

Bench ☒ Exists Material: **Brick** ☐ Parged ☒ **Debris** (not Condition related)

Channel Material: **Brick** ☐ Parged ☒ **Debris** (not Condition related)

Steps Count: **3** Missing: **0** ☒ **Corroded**

Corroded steps. Bench and Channel debris.

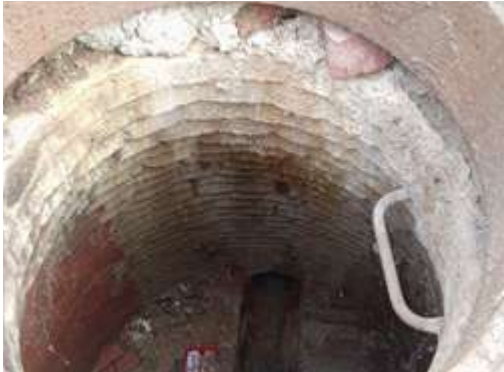
Defect

Frame Offset: **1** (in.) Condition: ☐ Sound ☐ Cracked ☒ **Leaks**

Condition: ☐ Sound ☐ Cracked ☐ Root Intrusion ☒ **Loose Brick** ☒ **Deteriorated**

Infiltration: ☐ None ☒ **Joint** ☐ Cracks ☐ Mortar ☐ Roots ☒ **Wall**

Frame leaks. Adjustment deterioration, loose brick and infiltration. Corbel and Barrel infiltration - other side.

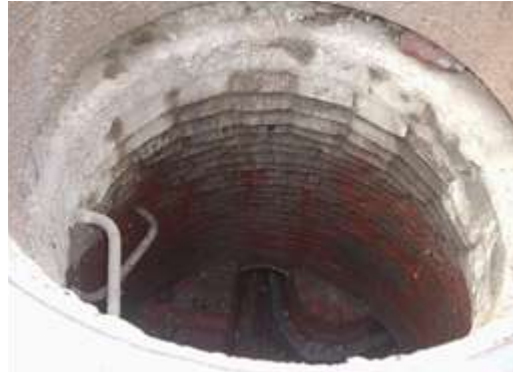
Defect

Frame leaks. Adjustment deterioration, loose brick and infiltration. Corbel and Barrel infiltration.

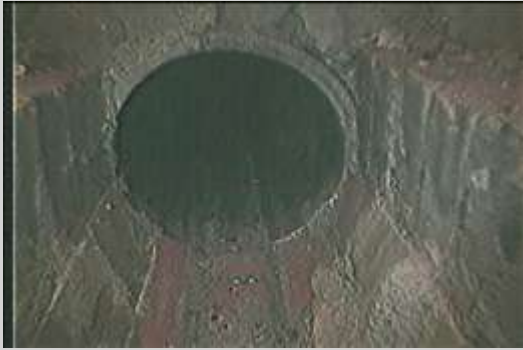
Pipe In @ 6 O'Clock

Pipe Seal Cond: **Cracked**
